NATIONAL REGISTER OF HISTORIC PLACES  
INVENTORY -- NOMINATION FORM

HISTORIC Fort Scott Historic Area

National Park Service  
Cultural Landscapes Inventory  
1998

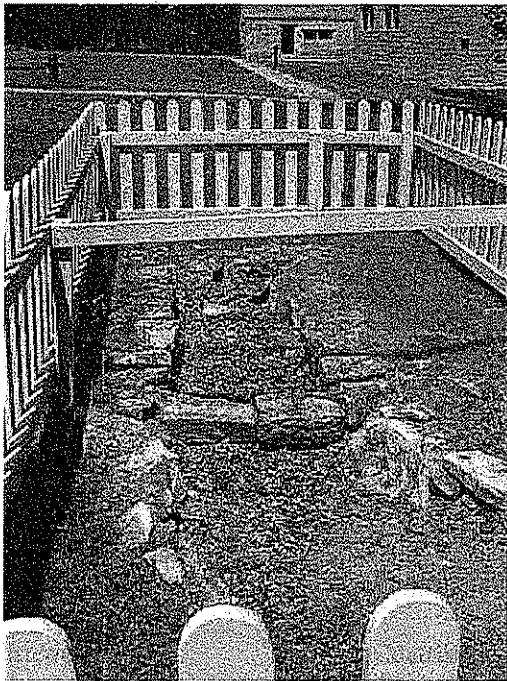
*Current view of privy (latrines) located behind HS-6. (CLI Level 2, 1998).*

HS-22 Latrine. Now only a site, this was formerly a two-room latrine completed by 1848 and located 300 yards southeast of the barracks (HS-6).

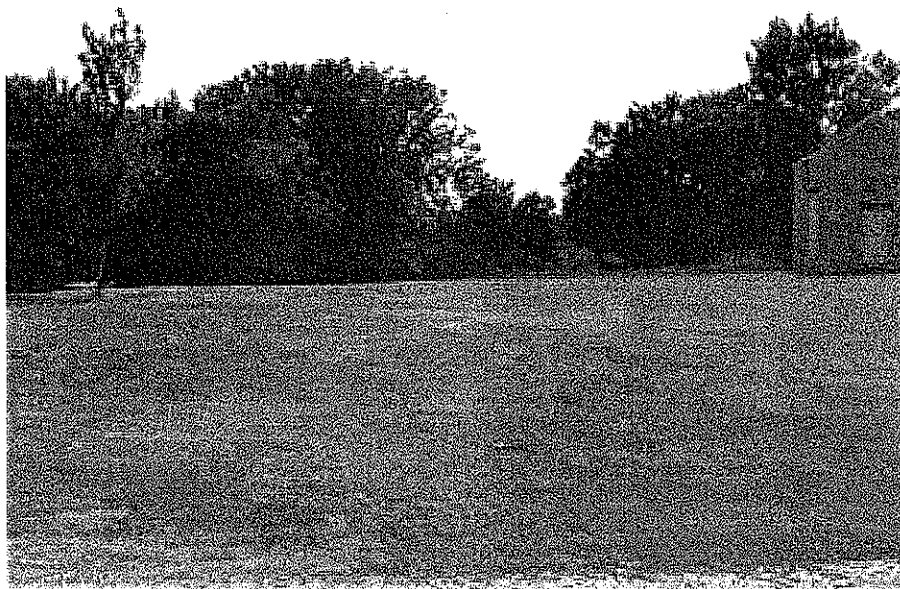
*View of area of where Quartermaster Quadrangle once existed. (CLI Level 2, 1998).*

HS-13 Quartermaster Stables. This was a large, enclosed compound 140' x 115' with a 21-stall stable and oat and corn cribs. Its site has been recently cleared of non-historic structures and the ground plan is being delineated.
